ARMY AVIATION TEST BOARD FORT RUCKER ALA
PRODUCT IMPROVEMENT TEST, ADDITIONAL ROOF ACCESS STEP FOR UH-1D-ETC(U)
MAR 68

SUBJECT: Letter Report Product Improvement Test, Additional Roof Access Step for UH-1D/H. USATECOM Project No.

4-5-0151-21

14 MAR 1968

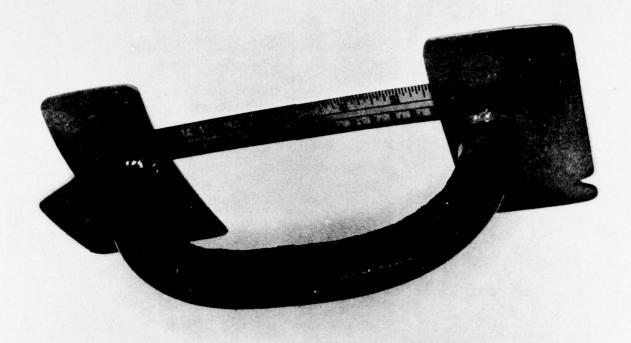
Figure 1

- 4. Description of Materiel. The access step (figure 1, inclosure) is constructed of one-inch tubing (0.032 wall 4130 alloy steel: Mil Spec 7-6736 Type 1 Cond N) coated on the top side with non-skid material (MIL-W-5044). The tube is a half-oval shape, providing a step about 7 inches wide extending 3 1/2 inches from the side of the helicopter. Plates for attachment of the step are welded on each end of the tube. The step weighs 1 pound and 10 ounces.

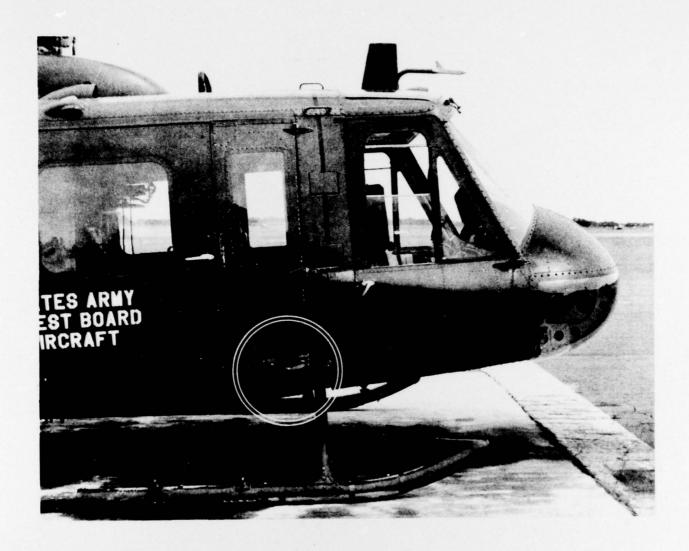
Figure 2

- a. The steps could be ascended easily without opening the right door. When descending the steps, personnel had a natural tendency to begin with the right foot, resulting in an awkward body position when the lower step was reached (figure 3).
- b. The step was large enough for personnel wearing combat boots (figure 4).
- c. The step did not interfere with loading or unloading of troops when the aircraft was on the ground.

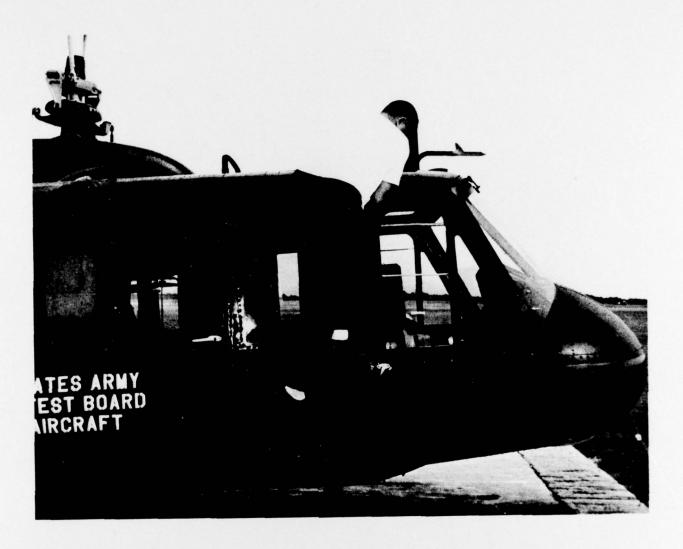
Figure 3

- 8. Conclusion. The additional roof access step is suitable for use on the UH-1D/H, but is located too far aft for ease of descent.
- 9. Recommendation. It is recommended that the additional step be mounted further forward, if feasible.
